Colville Wellbeing Centre

Geotechnical Factual Report

Prepared for Colville Community Health Trust

Prepared by Beca Limited

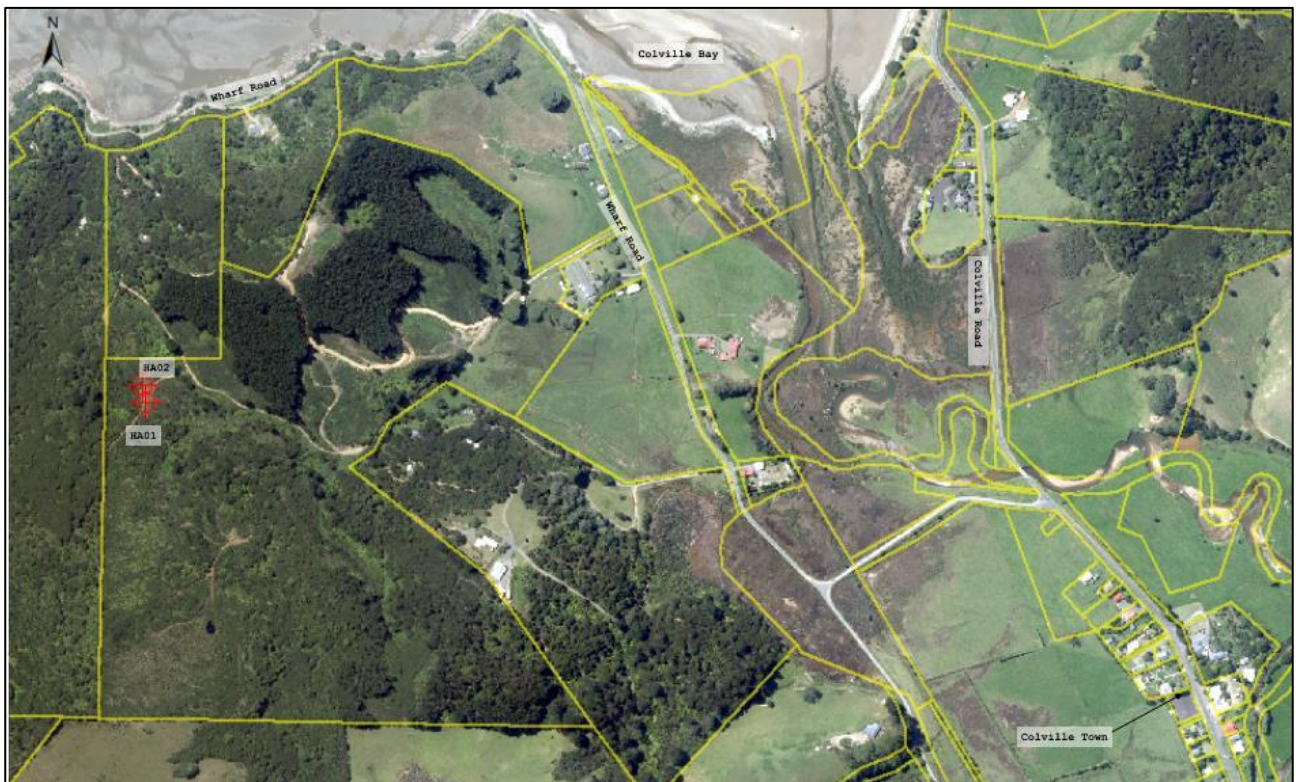
Figure 1. 89 Wharf Road property and location of hand augers, LINZ (2016-2019).

89 Wharf Road is located 1.4km northwest of Colville. The property is in a rural area with moderately sloping hill sides. The site is understood to be used as a timber supply for a local sawmill. The property and the location of geotechnical testing is indicated on the Geotechnical Investigation Location Plan (Appendix A) and Figure 1 below.

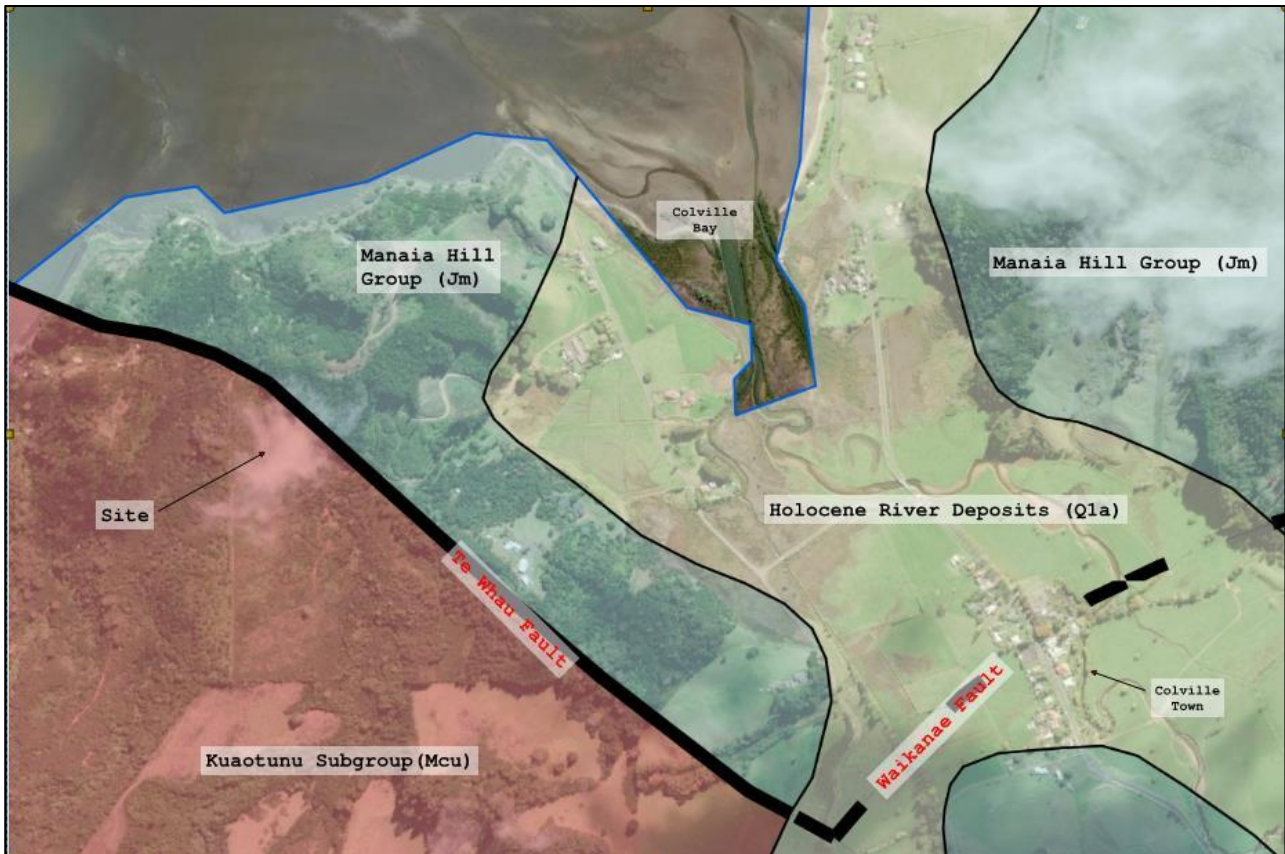
Figure 2 Surficial geology (Edbrooke, Colville).

The published geological map of the area is indicated in the Auckland QMAP (Edbrooke, 2001), refer Figure 2. The site area is underlain by Kuaotunu Subgroup (Mcu) dated between 10.9 and 18.5 million years. It is

mainly represented by basaltic andesite, andesite and dacite (volcanic lavas) and pyroclastic (volcanic eruption ejecta) as part of Coromandel Volcanic Zone.

Lowland areas are characterized by fluvial deposits (Q1a) which are up to 14,000 years old and comprise sand, silt mud and clay with local gravel and peat beds.

The basement rocks in the area comprise greywacke of the Manaia Hill Group (Jm) which is between 42 and 159 million years old.

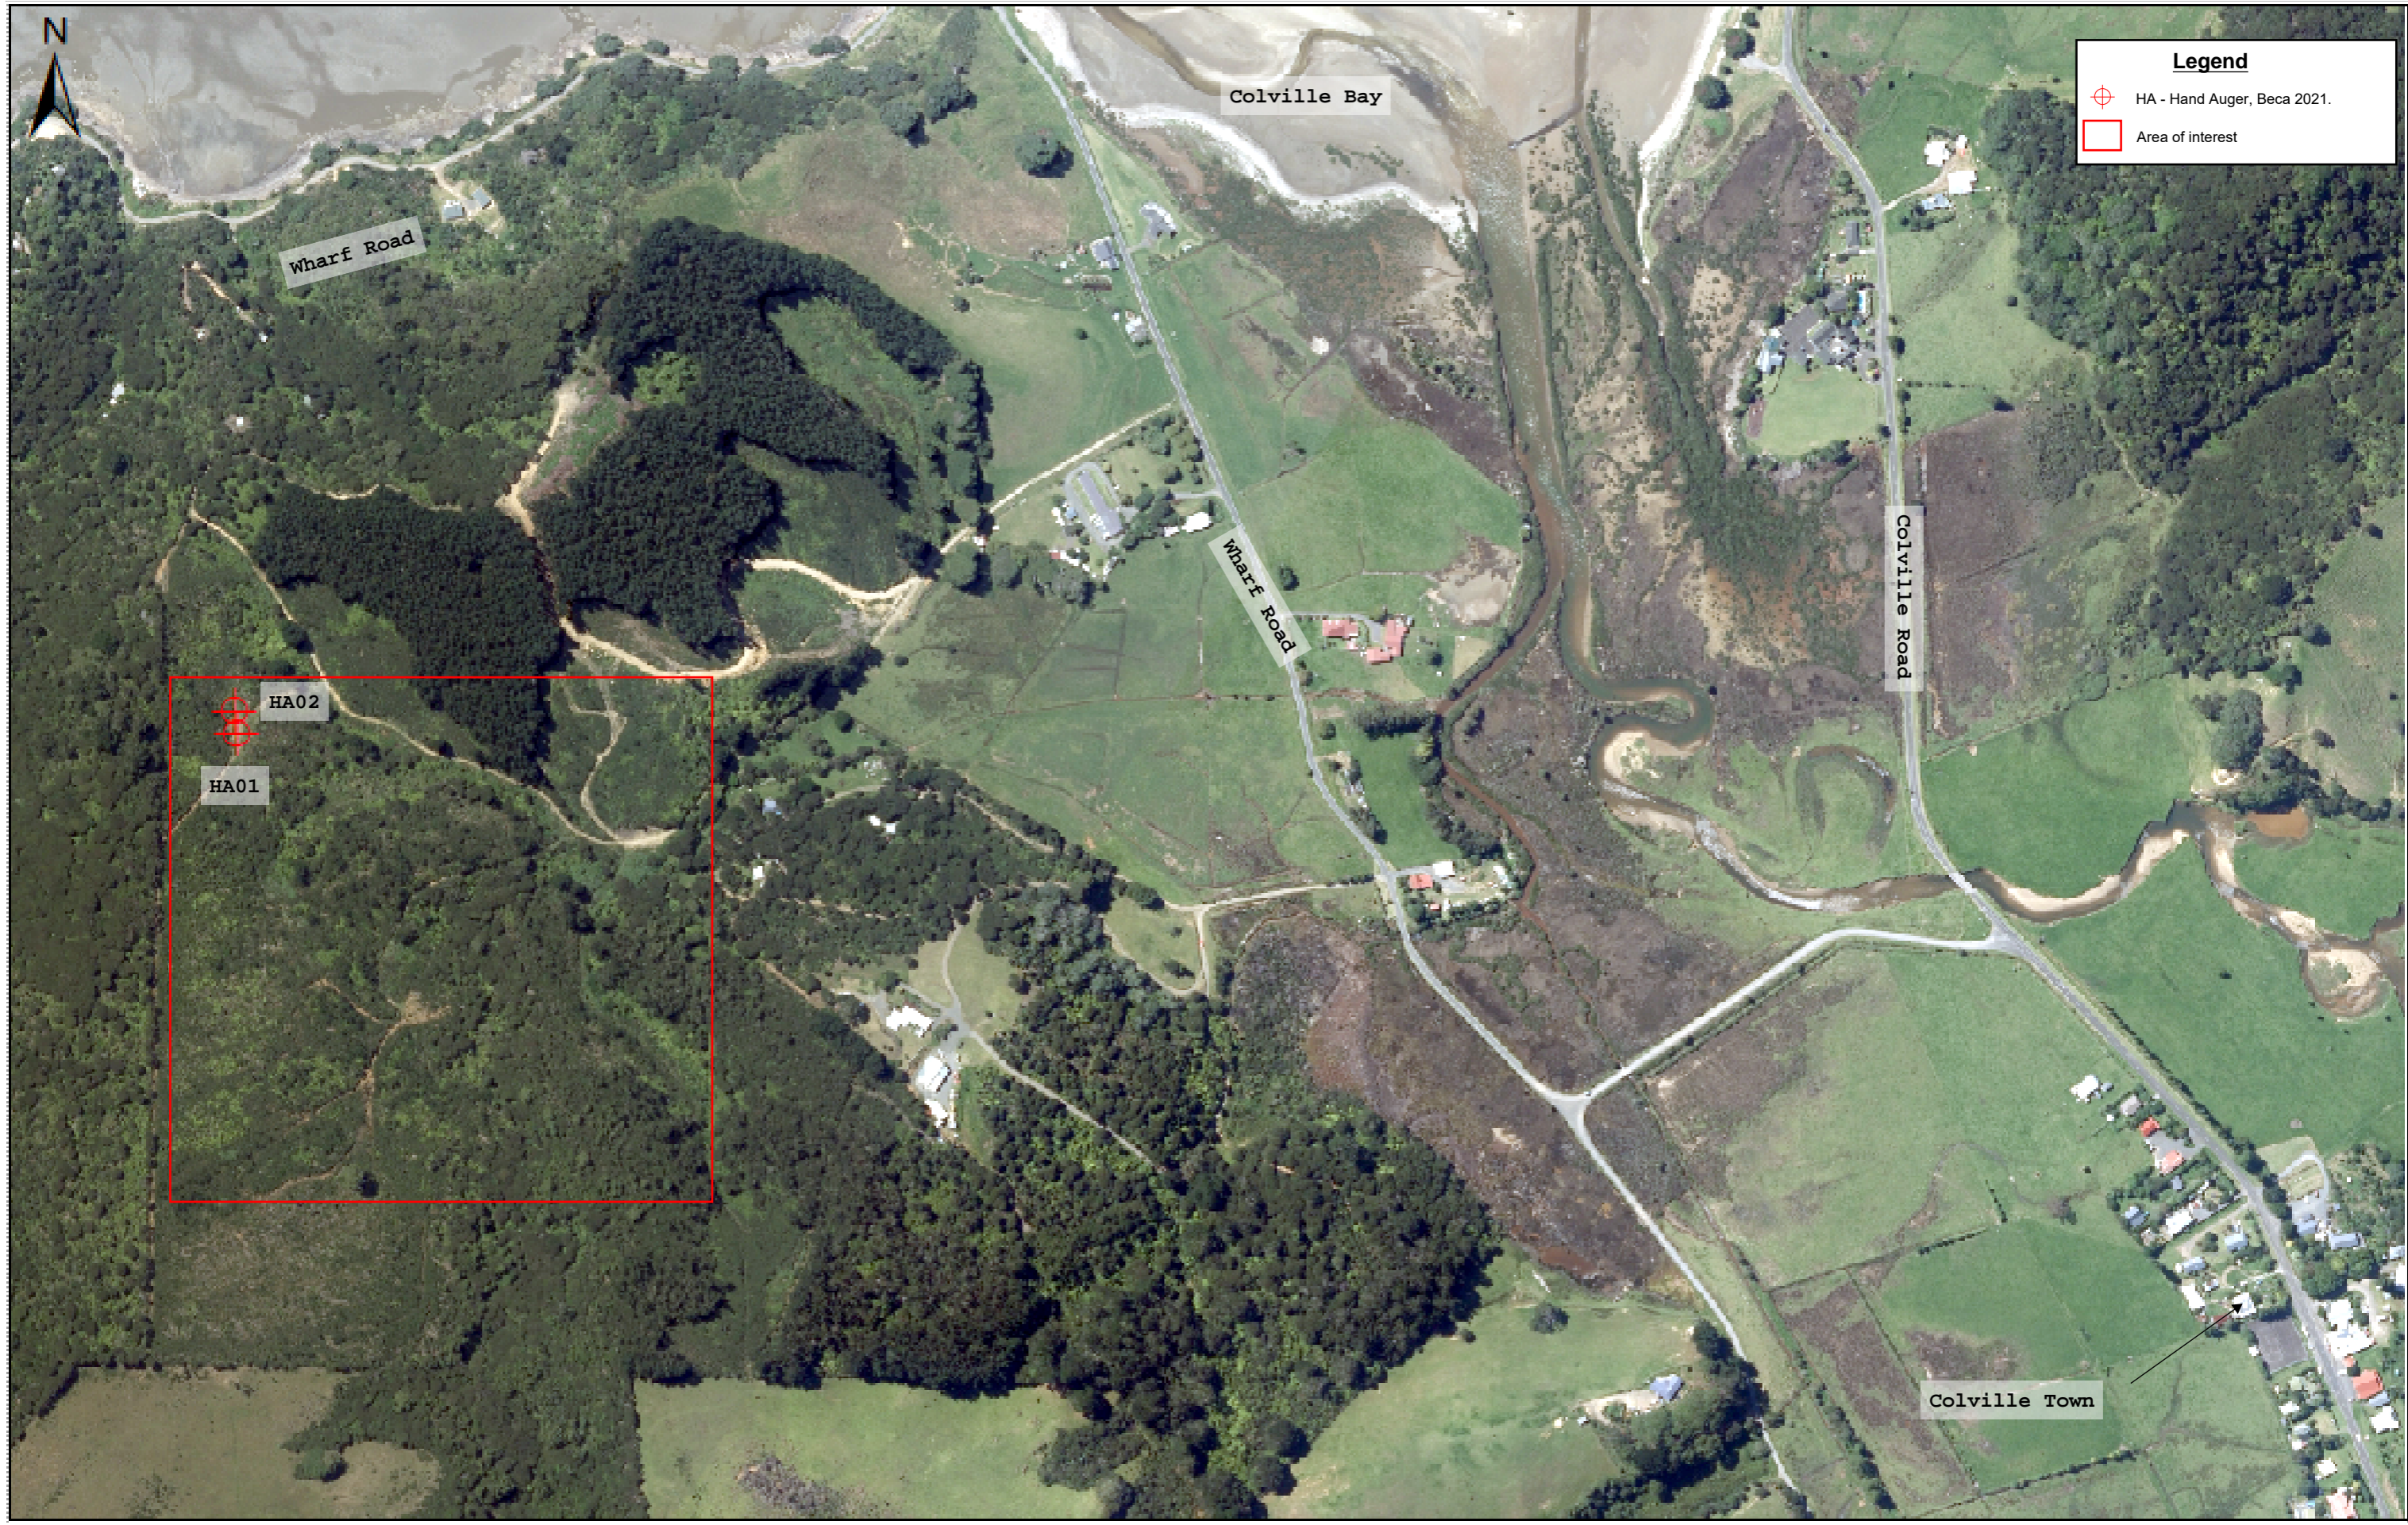
Title: GEOTECHNICAL INVESTIGATION LOCATION PLAN

HA - Hand Auger, Beca 2021.
-

Two hand augers were drilled and logged on site by Beca staff. The hand auger locations are shown in Geotechnical Investigation Location Plan in Appendix A. Hand auger logs and photographs are attached in Appendix B.

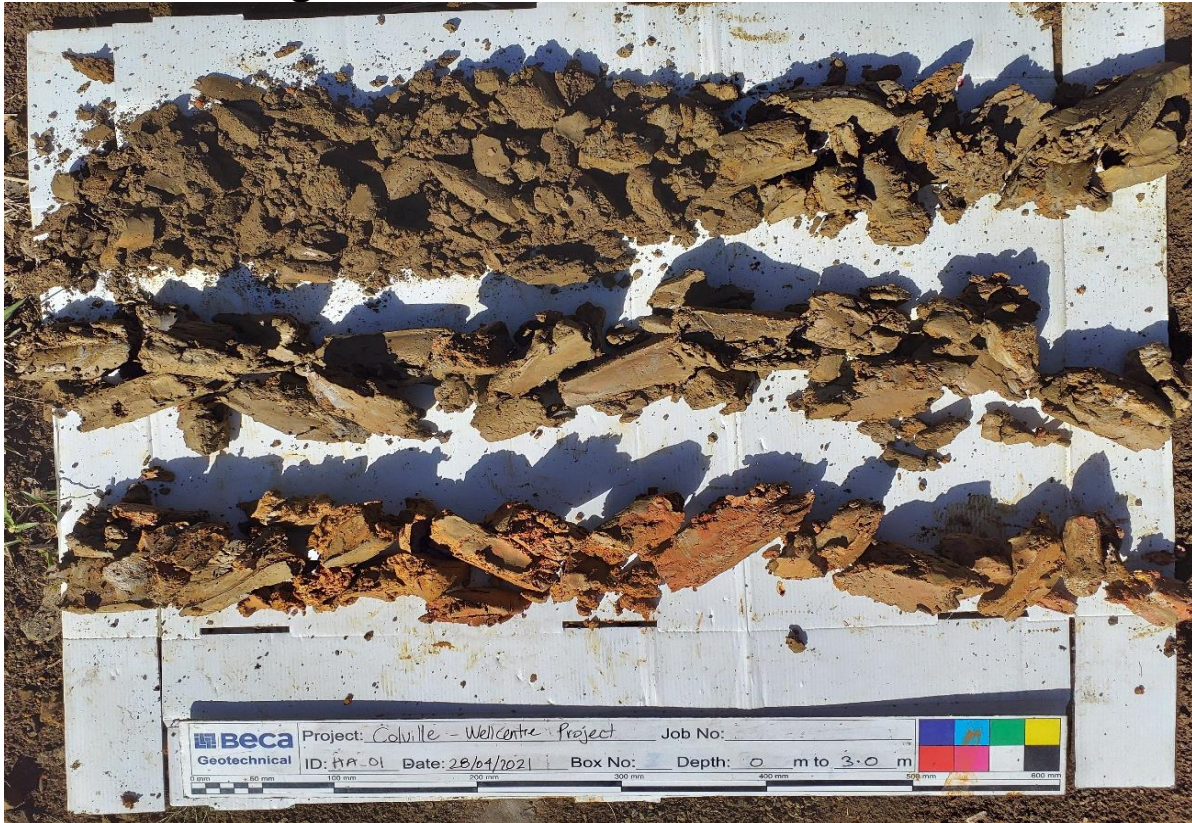
HA01

DEPTH: 0.0 to 3 m

Groundwater (m)	In Situ Tests		Samples	Depth (m)	RL (m)	Graphic Log	Soil/ Rock Description	Geological Unit
	Su (kPa)	Scala blows/50mm						
						x silt x	"Stiff" SILT with some clay, some organics, minor fine to medium sand; dark brown; moist, low plasticity. Organics: rootlets and amorphous.	Topsoil
	202/89			0.5	34.5	x x x x x	"Very stiff" SILT with some clay, minor fine to medium sand, trace organics; dark brown; moist, low plasticity.	Kuaotunu Subgroup
						x x x x x	Hard silty CLAY minor fine to medium sand; brown mottled grey; moist, high plasticity.	
	171/100			1.0	34.0	x x x x x	Very stiff silty CLAY minor fine to medium sand; grey with red (FeO) staining; moist, high plasticity.	
						x x x x x	Hard CLAY with some silt, minor fine to medium sand; greyish red, moist, high plasticity.	
	UTP			1.5	33.5	x x x x x		
						x x x x x	Very stiff CLAY with some silt, trace fine sand; reddish orange, moist, high plasticity.

171/81			2.0	33.0	x x x x x		
						x x x x x		
	141/95			2.5	32.5	x x x x x	Very stiff CLAY with some silt, trace fine gravel; white, red, brown with red yellow and grey mix, moist, high plasticity.	
						x x x x x		
	128/67			3.0	32.0	x x x x x	3.00m - End of hand auger	
						x x x x x

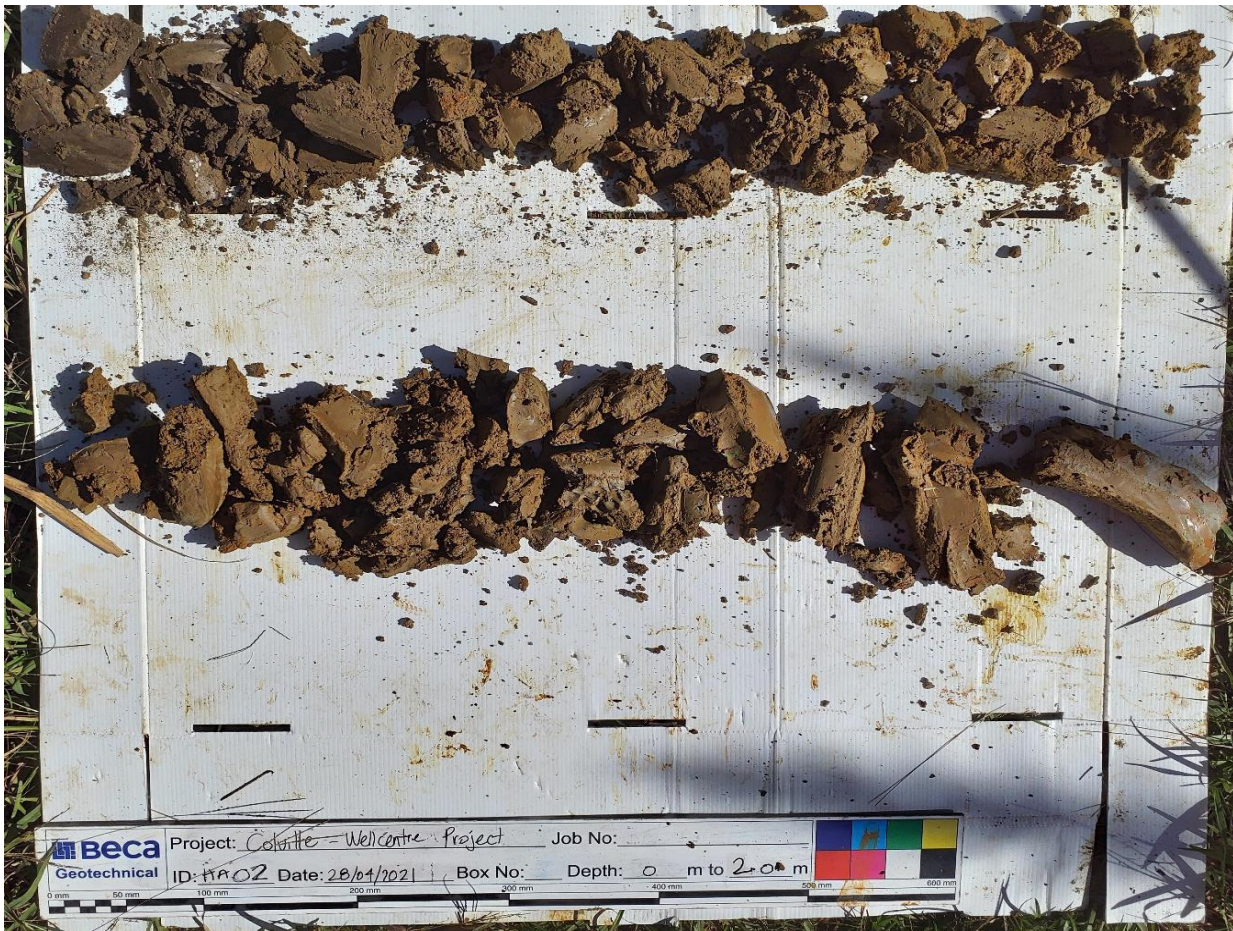
HA02

DEPTH: 0.0 to 2 m

Groundwater (m)	In Situ Tests		Samples	Depth (m)	RL (m)	Graphic Log	Soil/ Rock Description	Geological Unit
	Su (kPa)	Scala blows/50mm						
						x silt x	"Very stiff" SILT, minor clay, some organics trace fine to coarse sand; dark brown; dry, low plasticity. Organics: rootlets and amorphous.	Topsoil
	190/95			0.5	35.5	x x x x x	Very stiff, minor clay, trace fine to medium sand, trace organics; dark brown and grey mixture; moist, low plasticity. Organics: fibrous.	Kuaotunu Subgroup
	202			1.0	35.0	x x x x x	Hard SILT, minor clay, trace fine sand, trace fine gravel; dark greyish brown; moist, low plasticity.	
	183/100			1.5	34.5	x x x x x	Very stiff SILT, some clay, trace fine sand; grey with red and orange streaks; moist, high plasticity.	
	174/103			2.0	34.0	x x x x x	2.00m - End of hand auger	
				2.5	33.5			
				3.0	33.0			
				3.5	32.5			
				4.0	32.0			
				4.5	31.5
